ASBESTOS MANAGEMENT SURVEY

Site: Witcombe Green

Address: 19 High Street, Wroughton, Swindon, SN4 9JX

Survey Date: 12 November 2024

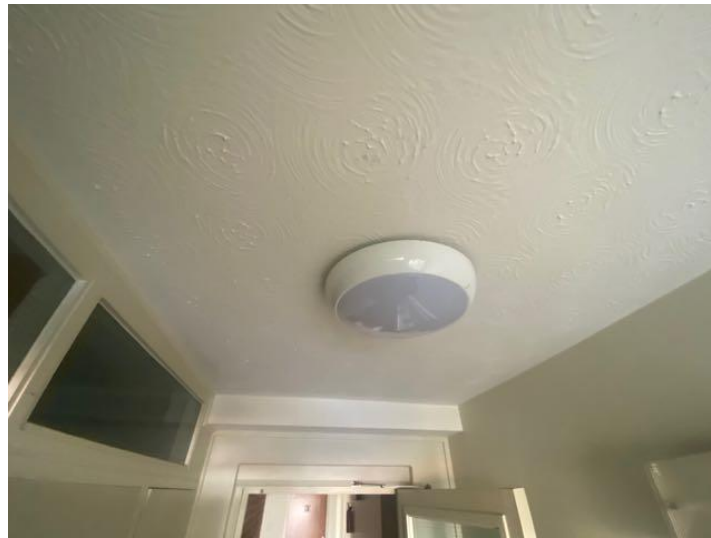
Sample Number:	S001		
Building:	19 High Street	Floor:	Ground Floor
Room Name/Number:	G.01 - Entrance Lobby	Material/Amount:	Textured Coating 3 m ²
Sample Description:	Textured coating to plasterboard ceiling

Product Type:	Textured Coating	Total Risk Score:	3
Condition:	Some Minor Damage	Risk Category:	Very Low
Surface Treatment:	Composite/Self Sealed		
Asbestos Types:	Chrysotile	Action:	Manage
Comments:	Periodic inspections should be carried out in accordance with Regulation 4 of the Control of Asbestos Regulations 2012. Do not disturb this ACM. Ensure all employees, contractors & tenants who may come into contact with this ACM are made aware.

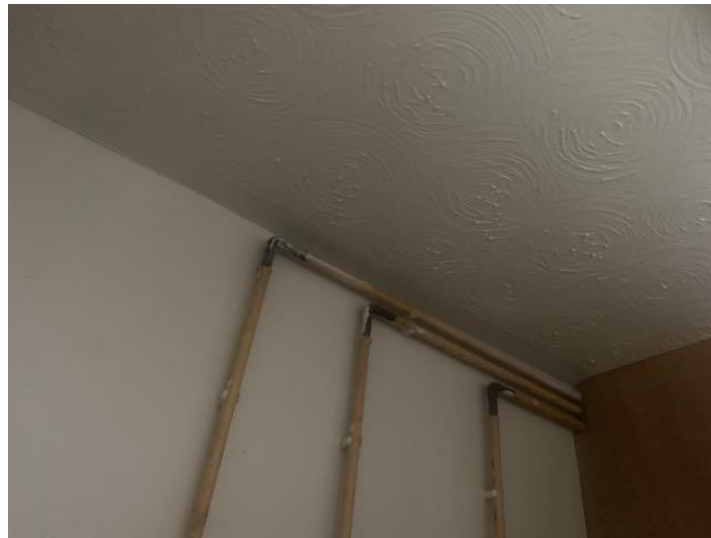
Sample Number:	X001-1		
Building:	19 High Street	Floor:	Ground Floor
Room Name/Number:	G.02 - Redundant gas meter cupboard	Material/Amount:	Textured Coating 1 m ²
Sample Description:	Textured coating to plasterboard ceiling

Product Type:	Textured Coating	Total Risk Score:	3
Condition:	Some Minor Damage	Risk Category:	Very Low
Surface Treatment:	Composite/Self Sealed		
Asbestos Types:	Chrysotile	Action:	Manage
Comments:	Periodic inspections should be carried out in accordance with Regulation 4 of the Control of Asbestos Regulations 2012. Do not disturb this ACM. Ensure all employees, contractors & tenants who may come into contact with this ACM are made aware.

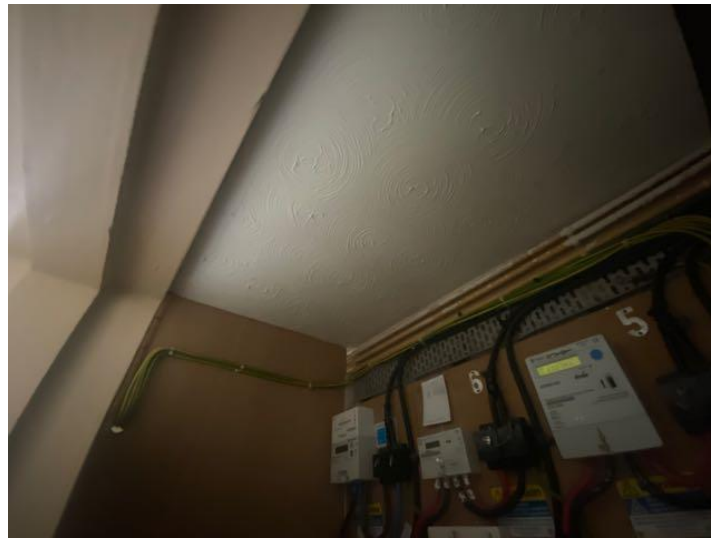
Sample Number:	X001-2		
Building:	19 High Street	Floor:	Ground Floor
Room Name/Number:	G.03 - Electric intake	Material/Amount:	Textured Coating 1 m ²
Sample Description:	Textured coating to plasterboard ceiling

Product Type:	Textured Coating	Total Risk Score:	3
Condition:	Some Minor Damage	Risk Category:	Very Low
Surface Treatment:	Composite/Self Sealed		
Asbestos Types:	Chrysotile	Action:	Manage
Comments:	Periodic inspections should be carried out in accordance with Regulation 4 of the Control of Asbestos Regulations 2012. Do not disturb this ACM. Ensure all employees, contractors & tenants who may come into contact with this ACM are made aware.

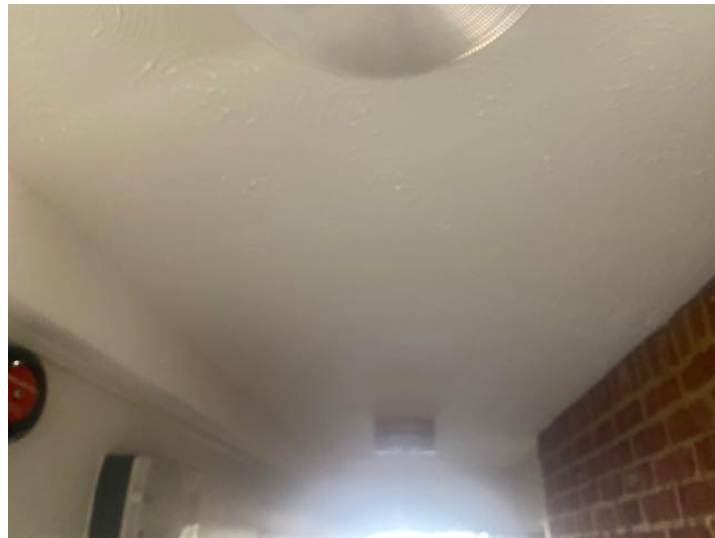
Sample Number:	X001-3		
Building:	19 High Street	Floor:	Ground Floor
Room Name/Number:	G.04 - Lobby	Material/Amount:	Textured Coating 6 m ²
Sample Description:	Textured coating to plasterboard ceiling

Product Type:	Textured Coating	Total Risk Score:	3
Condition:	Some Minor Damage	Risk Category:	Very Low
Surface Treatment:	Composite/Self Sealed		
Asbestos Types:	Chrysotile	Action:	Manage
Comments:	Periodic inspections should be carried out in accordance with Regulation 4 of the Control of Asbestos Regulations 2012. Do not disturb this ACM. Ensure all employees, contractors & tenants who may come into contact with this ACM are made aware.

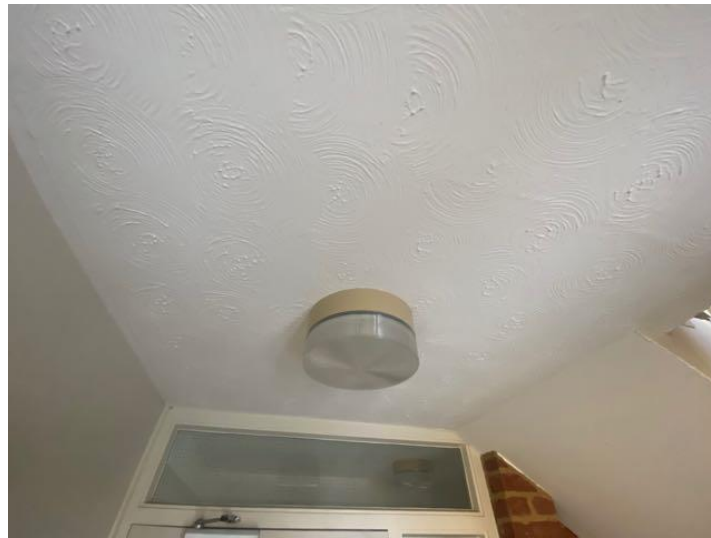
Sample Number:	X001-4		
Building:	19 High Street	Floor:	Ground Floor
Room Name/Number:	ST.01 - Ground to first	Material/Amount:	Textured Coating 2 m ²
Sample Description:	Textured coating to plasterboard ceiling

Product Type:	Textured Coating	Total Risk Score:	3
Condition:	Some Minor Damage	Risk Category:	Very Low
Surface Treatment:	Composite/Self Sealed		
Asbestos Types:	Chrysotile	Action:	Manage
Comments:	Periodic inspections should be carried out in accordance with Regulation 4 of the Control of Asbestos Regulations 2012. Do not disturb this ACM. Ensure all employees, contractors & tenants who may come into contact with this ACM are made aware.

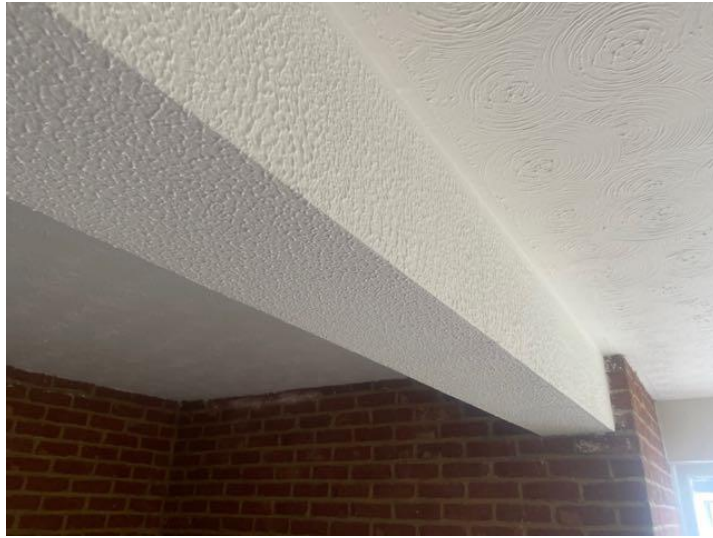
Sample Number:	S004		
Building:	19 High Street	Floor:	1st Floor
Room Name/Number:	ST.01 - Ground to first	Material/Amount:	Textured Coating 4 lin m
Sample Description:	Textured coating to plasterboard boxing

Product Type:	Textured Coating	Total Risk Score:	3
Condition:	Some Minor Damage	Risk Category:	Very Low
Surface Treatment:	Composite/Self Sealed		
Asbestos Types:	Chrysotile	Action:	Manage
Comments:	Periodic inspections should be carried out in accordance with Regulation 4 of the Control of Asbestos Regulations 2012. Do not disturb this ACM. Ensure all employees, contractors & tenants who may come into contact with this ACM are made aware.

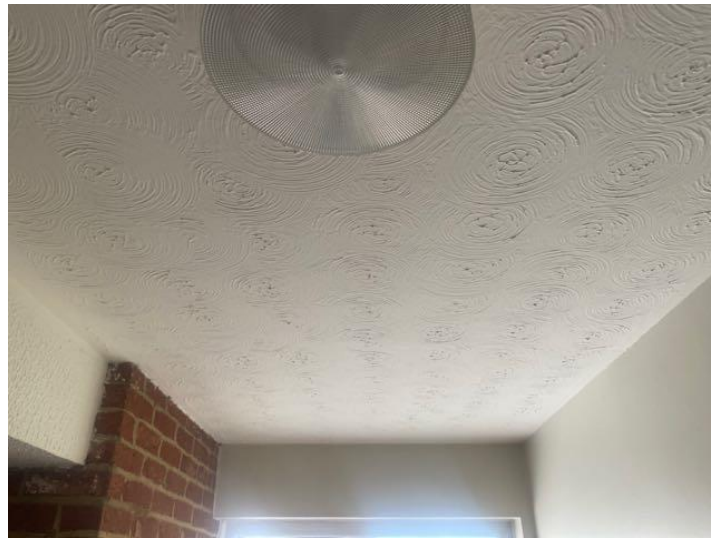
Sample Number:	S005		
Building:	19 High Street	Floor:	1st Floor
Room Name/Number:	ST.01 - Ground to first	Material/Amount:	Textured Coating 8 m ²
Sample Description:	Textured coating to plasterboard ceiling

Product Type:	Textured Coating	Total Risk Score:	3
Condition:	Some Minor Damage	Risk Category:	Very Low
Surface Treatment:	Composite/Self Sealed		
Asbestos Types:	Chrysotile	Action:	Manage
Comments:	Periodic inspections should be carried out in accordance with Regulation 4 of the Control of Asbestos Regulations 2012. Do not disturb this ACM. Ensure all employees, contractors & tenants who may come into contact with this ACM are made aware.

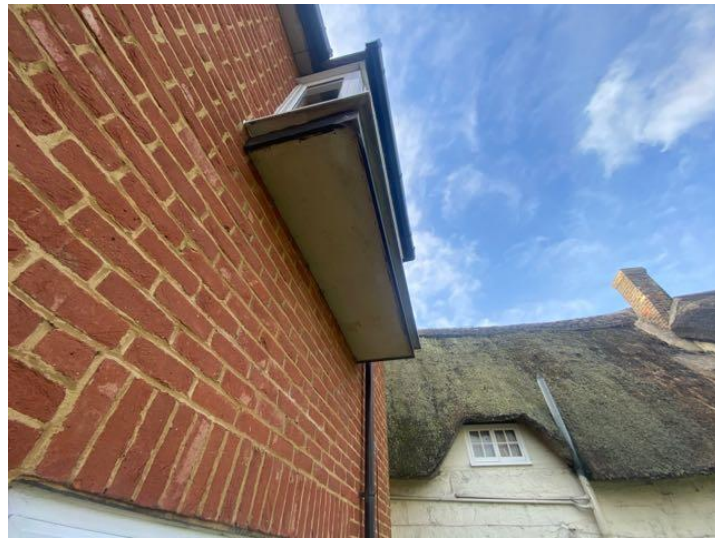
Sample Number:	P007		
Building:	19 High Street	Floor:	External
Room Name/Number:	E.01 - Externals	Material/Amount:	Cement Product 4 - Total m ²
Sample Description:	Presumed cement board beneath window boxes

Product Type:	Cement Product	Total Risk Score:	4
Condition:	Some Minor Damage	Risk Category:	Very Low
Surface Treatment:	Sealed		
Asbestos Types:	Chrysotile	Action:	Manage

Comments: Note: one to the front elevation and three to the rear of the property.
 Periodic inspections should be carried out in accordance with Regulation 4 of the Control of Asbestos Regulations 2012. Do not disturb this ACM. Ensure all employees, contractors & tenants who may come into contact with this ACM are made aware.

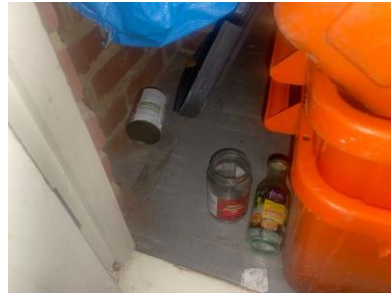
Sample No	Location	Material	Description	Quantity	Method	Sample Photo	Result
S002	19 High Street, Ground Floor, G.05 - Under stairs cupboard	Vinyl Products	Vinyl covering to concrete floor	2 m ²	Sampled

No Asbestos Detected
X002-1	19 High Street, Ground Floor, ST.01 - Ground to first	Vinyl Products	Vinyl covering beneath modern vinyl covering	Approx 25 m ²	Cross Reference

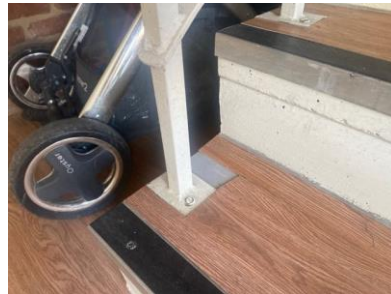
No Asbestos Detected

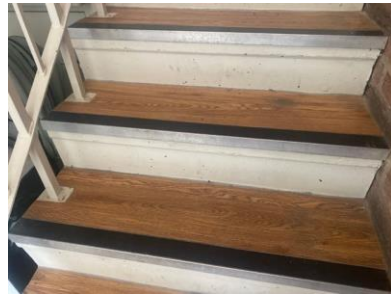
Sample No	Location	Material	Description	Quantity	Method	Sample Photo	Result
S003	19 High Street, Ground Floor, ST.01 - Ground to first	Bituminous Product	Stair nosings to steps	14 no	Sampled

No Asbestos Detected
S006	19 High Street, 2nd Floor, 2.01 - Roof space	Bituminous Product	Roofing felt to underside of roof	Throughout roof space	Sampled

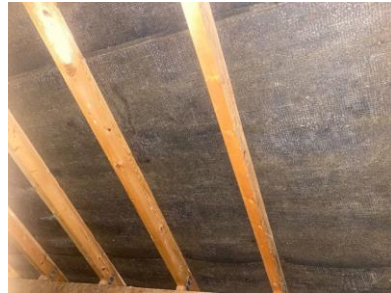
No Asbestos Detected
